Manhole Inspection Summary

Manhole # S11EE2032MH

Insp Date: **10/19/06 11:25 AM**

Location Address: **2311 CROSS COUNTRY BLVD**

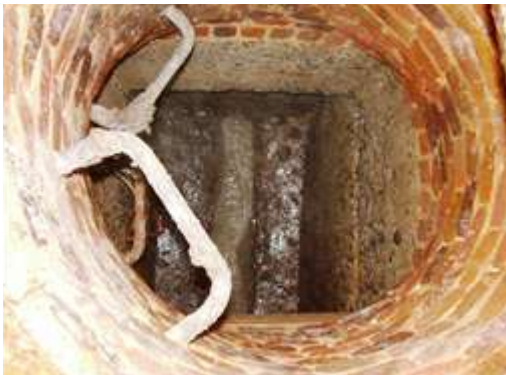
Top View

Evidence of surcharge - Bench debris.
Corroded steps.

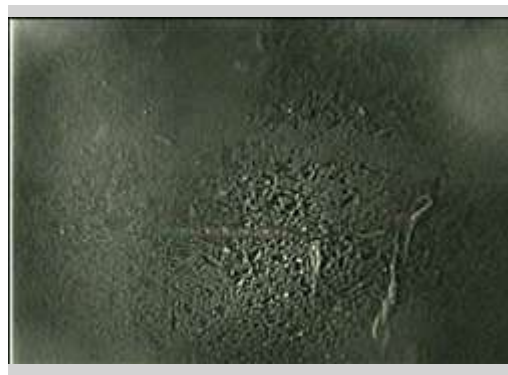
Evidence of surcharge

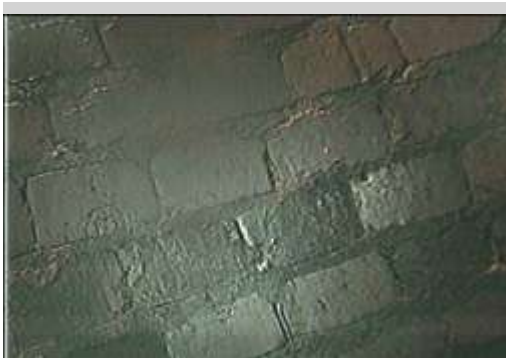
Defect

Corbel and Barrel infiltration.

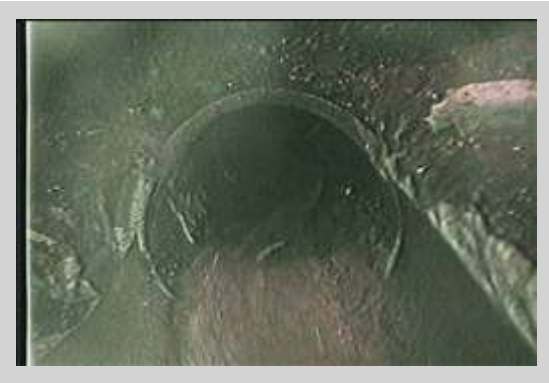
10 in. Circular Gravity Sewer Pipe Out @ 12 O'Clock

Infiltration: **Evidence** Pipe Seal Cond: **Roots**
